DEPARTMENT OF TRANSPORTATION**DIVISION OF ENGINEERING SERVICES**

Contract #: 04-0120F4Cty: SF/ALA Rte: 80 PM: 13.2/13.9File #: 69.28**WELDING INSPECTION REPORT****Resident Engineer:**Siegenthaler, Peter**Address:** 333 Burma Road**City:** Oakland, CA 94607**Report No:** WIR-020648**Date Inspected:** 13-Feb-2011**Project Name:** SAS Superstructure**OSM Arrival Time:** 700**Prime Contractor:** American Bridge/Fluor Enterprises, a JV**OSM Departure Time:** 1900**Contractor:** Zhenhua Port Machinery Company, Ltd (ZPMC), Changxing Island **Location:** Shanghai, China**CWI Name:** Zhu Zhong Hai**CWI Present:** Yes No**Inspected CWI report:** Yes No N/A**Rod Oven in Use:** Yes No N/A**Electrode to specification:** Yes No N/A**Weld Procedures Followed:** Yes No N/A**Qualified Welders:** Yes No N/A**Verified Joint Fit-up:** Yes No N/A**Approved Drawings:** Yes No N/A**Approved WPS:** Yes No N/A**Delayed / Cancelled:** Yes No N/A**Bridge No:** 34-0006**Component:** Orthotropic Box Girder(OBG)**Summary of Items Observed:**

WELDING:**Segment 14W**

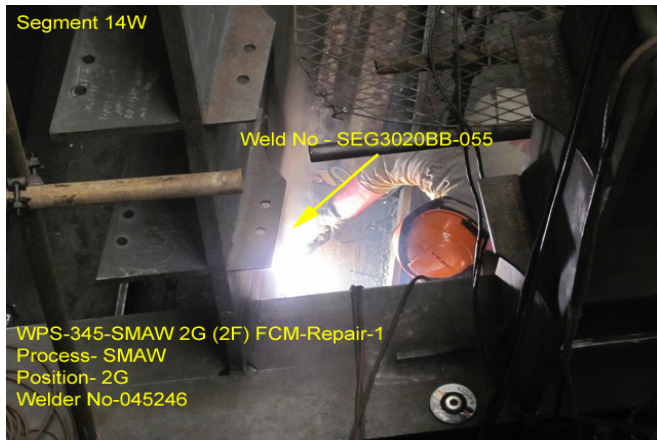
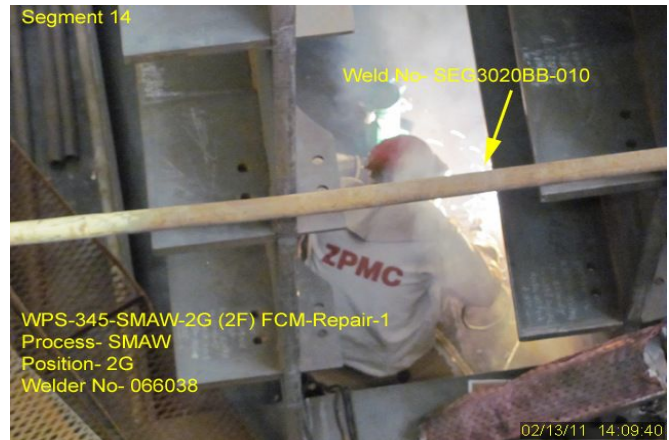
This QA Inspector observed ZPMC qualified welding personnel identified as 066038 perform Shielded Metal Arc Welding (SMAW), weld joint identified as SEG3020BB-010; located On Orthotropic Box Girder (OBG) SA34442A to BP3090A CJP Weld; ABF Quality Assurance (QA) is identified as Mr. Yan Bao Jia. The Critical Welding Repair Report (CWRR) was B-CWR2793 .This QA Inspector observed a welding current of approximately 230 amps and 25.4 volts and the base material appears to have been being preheated by an electrical heating elements prior to welding. ABF Quality Assurance (QA) Mr. Yan Bao Jia was onsite monitoring the welding variables. The welding variables recorded by QA appeared to comply with applicable WPS-345-SMAW-2G (2F) FCM-Repair-1. See attached photo for further details.

This QA Inspector observed ZPMC qualified welding personnel identified as 045246 perform Shielded Metal Arc Welding (SMAW), weld joint identified as SEG3020BB-055; located On Orthotropic Box Girder (OBG) SA34442A to BP3090A CJP Weld; ABF Quality Assurance (QA) is identified as Mr. Yan Bao Jia. The Critical Welding Repair Report (CWRR) was B-CWR2752 .This QA Inspector observed a welding current of approximately 230 amps and 25.4 volts and the base material appears to have been being preheated by an electrical heating elements prior to welding. ABF Quality Assurance (QA) Mr. Yan Bao Jia was onsite monitoring the welding variables. The welding variables recorded by QA appeared to comply with applicable WPS-345-SMAW-2G (2F) FCM-Repair-1. See attached photo for further details.

This QA Inspector observed ZPMC qualified welding personnel identified as 0675888 perform Shielded Metal Arc Welding (SMAW), weld joint identified as SEG3020U-588; located On Orthotropic Box Girder (OBG) Vertical Anchor Plate to Bottom Plate CJP Weld; ABF Quality Assurance (QA) is identified as Mr. Yan Bao Jia. This QA Inspector observed a welding current of approximately 232 amps and 25.4 volts and the base material appears to have been being preheated by an electrical heating elements prior to welding. ABF Quality Assurance (QA) Mr. Yan Bao Jia was onsite monitoring the welding variables. The welding variables recorded by QA appeared to comply with applicable WPS-B-P-2212-TC-U4b-FCM. See attached photo for further details.

This QA Inspector observed ZPMC qualified welding personnel identified as 037779 perform Shielded Metal Arc Welding (SMAW), weld joint identified as SEG3020U-588; located On Orthotropic Box Girder (OBG) Deck Plate to Deck Panel Diaphragm CJP Weld; ABF Quality Assurance (QA) is identified as Mr. Shao Jian Yuan. This QA Inspector observed a welding current of approximately 224 amps and 25.6 volts and the base material appears to have been being preheated by an electrical heating elements prior to welding. ABF Quality Assurance (QA) Mr. Shao Jian Yuan was onsite monitoring the welding variables. The welding variables recorded by QA appeared to comply with applicable WPS-B-P-2212-TC-U4b-FCM. See attached photo for further details.
